From: [Delano, Frances](#)
To: [Zeno, Denise](#)
Cc: [Schofield, Susan](#)
Subject: Site visit and pending items
Date: Monday, January 21, 2013 12:52:35 PM
Attachments: [PRIDCO PedernalesIndustrial Park.pdf](#)
[Proposed Continuous Water Level Monitoring reviewed.xlsx](#)

Cabo Rojo Site Discovery Initiative

PEDERNALES INDUSTRIAL PARK 1
CABO ROJO, PUERTO RICO

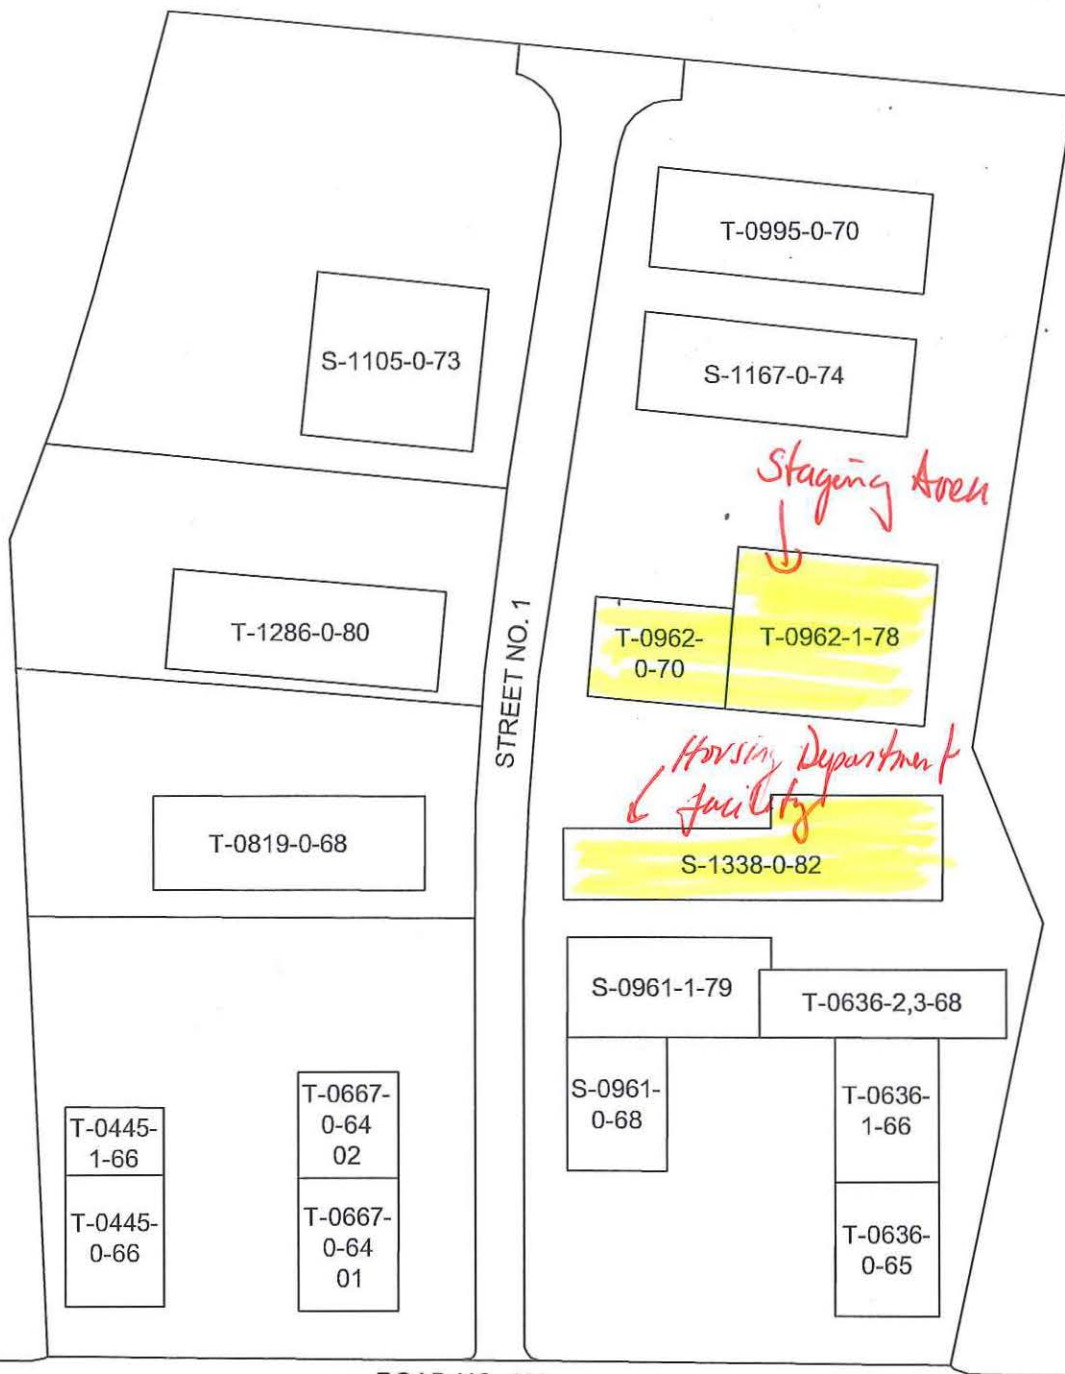
3

- a. The facility requested to PRIDCO to be used as the staging area (S-1105-0-73) was found to be separated by a fence to the parking lot west of the main building. The parking area is partially fenced and in the southwestern corner has an open access to a green area and further west road PR-100. The fence has been broken in several areas by apparently trespassers and in many areas is cover by overgrown vegetation. There is no lighting in the general area. Though we have been told by neighbors that the entrance to the industrial park is used as a lovers lane, we believe that the inactive facility which we identified (S-1338-0-82) in the beginning to be our staging area would work the best since the one next door has security, the fence is in much better condition and we could request the police to include this street in their night rounds. Also, it appears that the Reto plant, across the street, has security too. The PRIDCO representative and myself entered the inactive/empty building, he told me it has been inactive for a long time. We should try to talk to Karen to get this facility and for her field team to repair the fence (two holes). We have coordinated with the suppliers to start mobilization on January
